REPORT OF INVESTIGATION
(UNDERGROUND COAL MINE)

NONFATAL ROOF FALL

Beaver Creek Coal Company
Trail Mountain #9 Mine (ID No. 42-01211)
Orangeville, Emery County, Utah

October 21, 1987

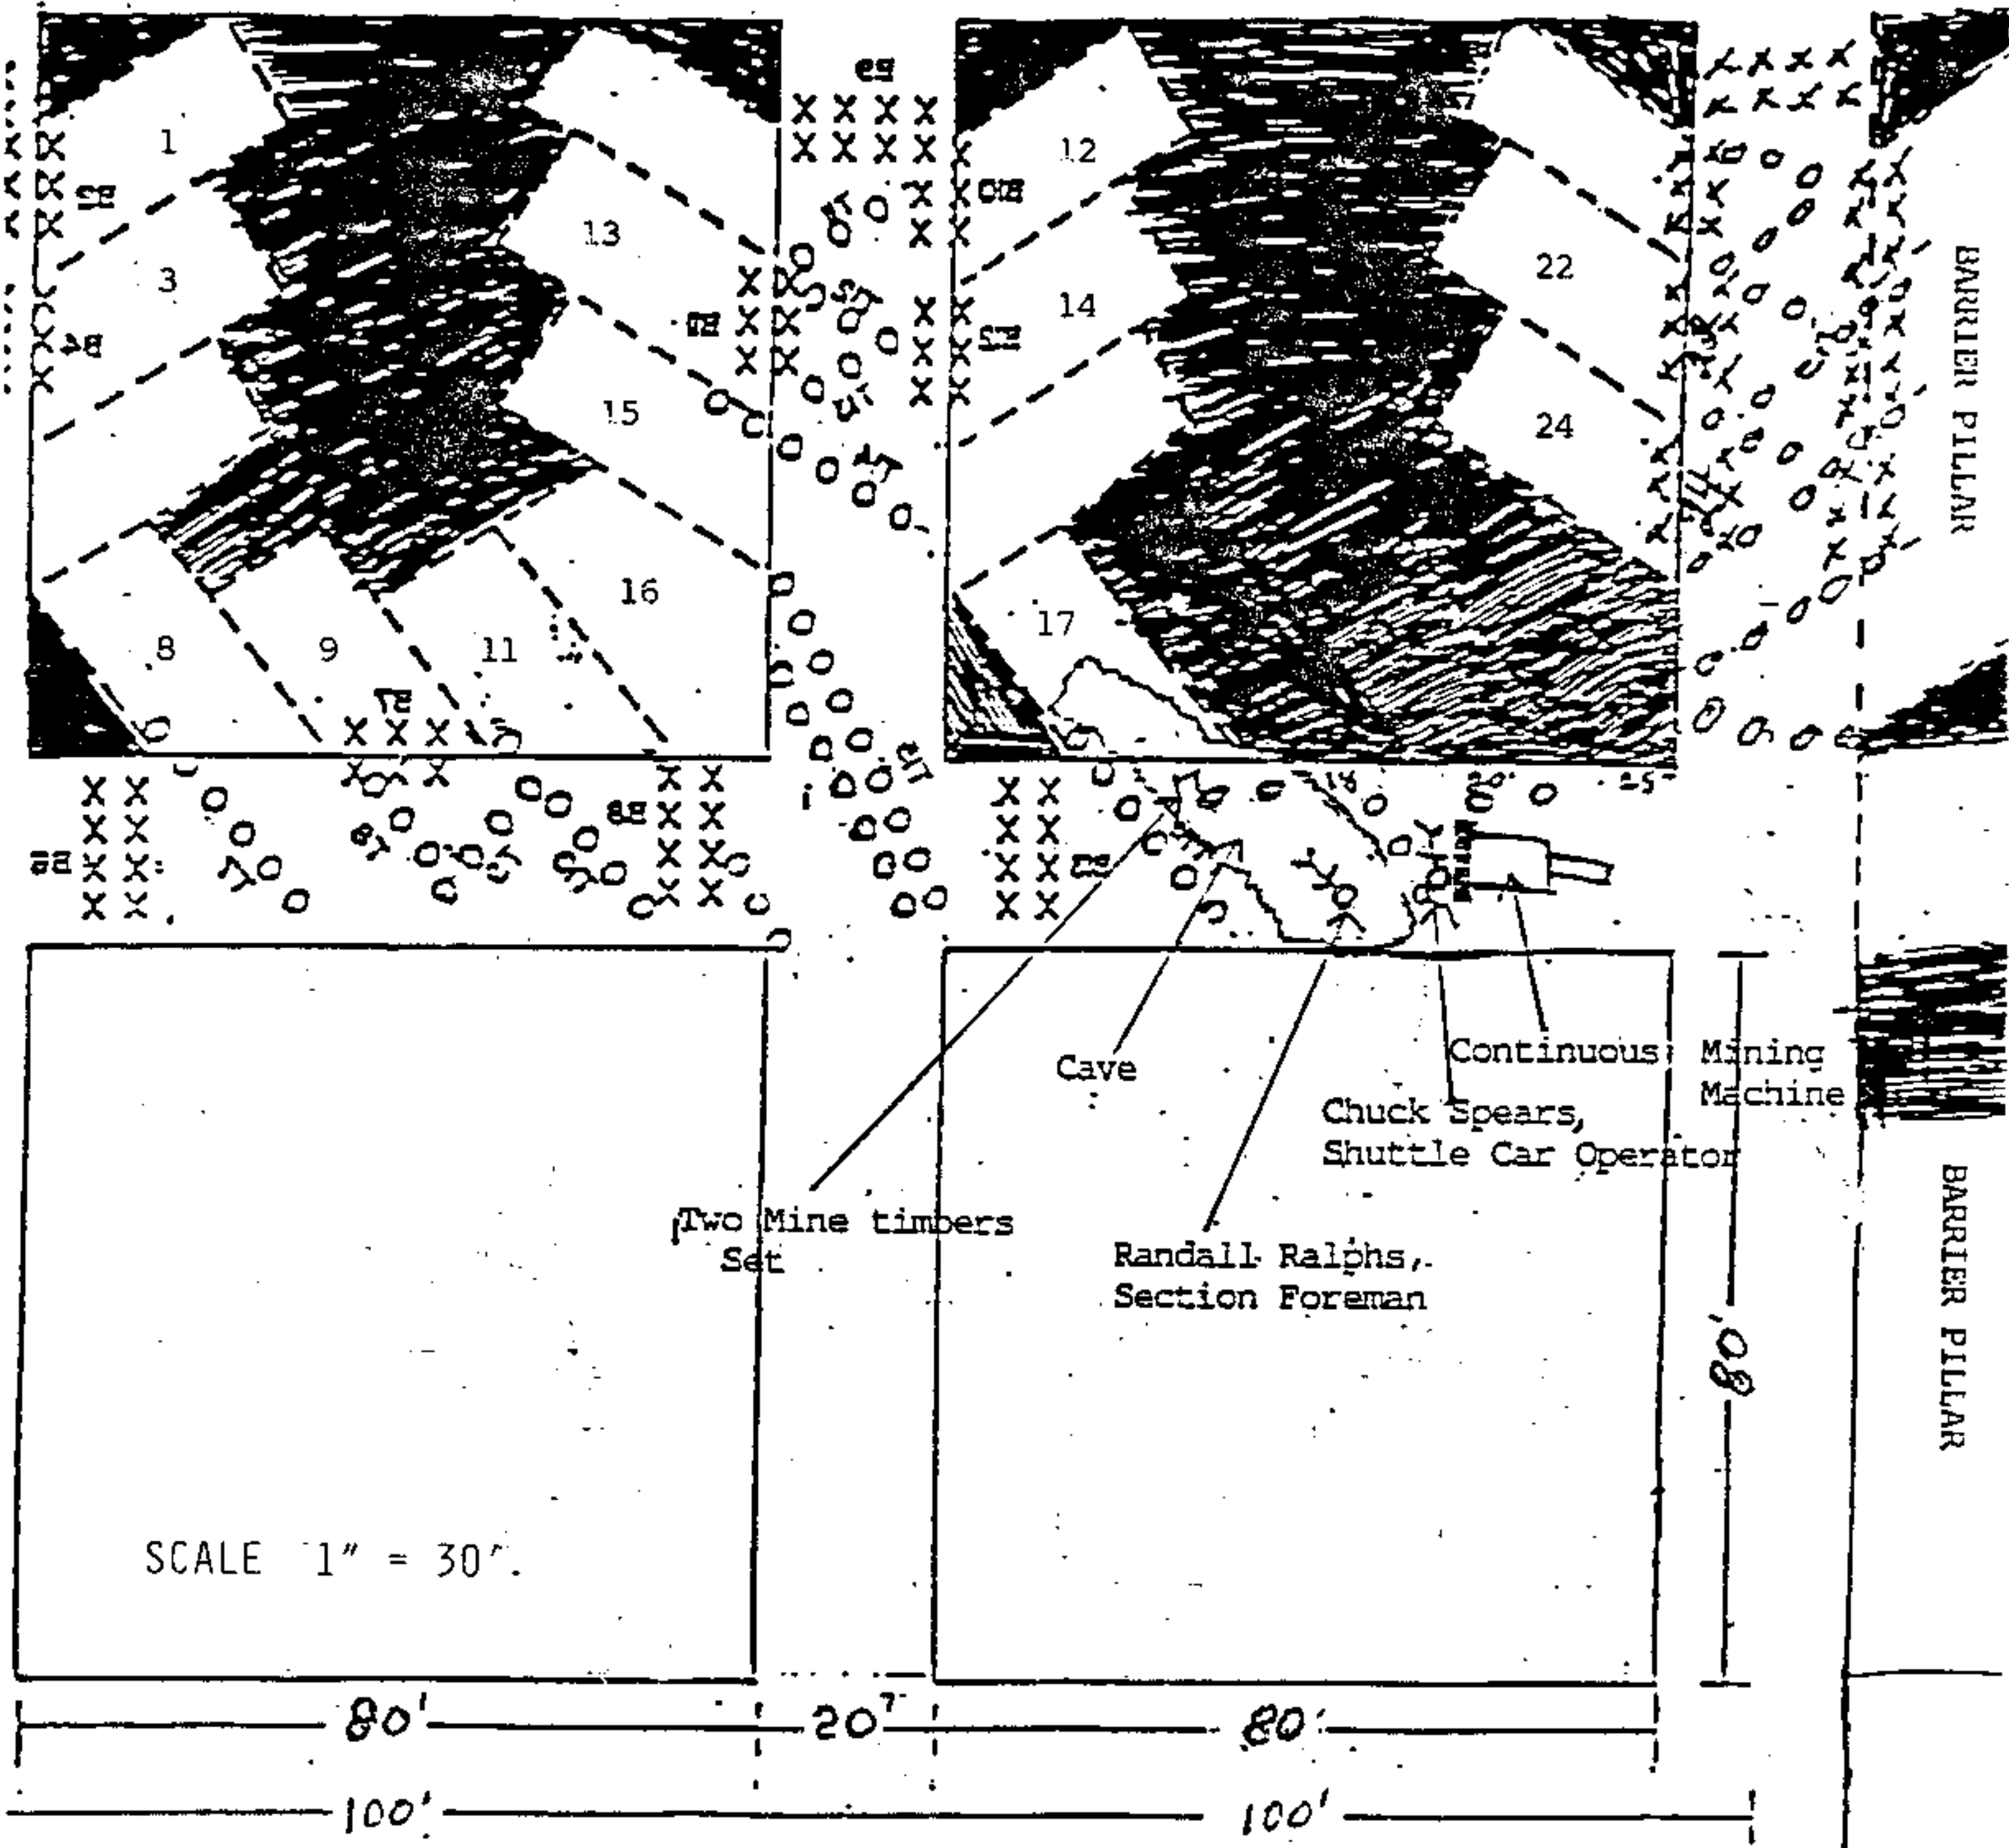
PERIMETER EXTRACTION
PILLAR PLAN - A

NOTE: This is a mirror image of the approved plan, pg. 21.

4. Because of cutting out of sequence in mirror image, the No. 17 pillar block had been mined to the left and right, plus the barrier pillar had been mined, allowing about 2000 feet of cover to be sitting on top of the small pillar stump.
